RESERVOIRS

The chapter on Masonry Dams has been increased twofold by an attempt to make some mention of all the most notable dams of the world, and many that are very little known. Attention is particularly directed to Plates 1, 2, and 3, in which profiles are shown of all of the leading and better known masonry dams in existence, drawn to uniform scale for easy graphical comparison. No such complete collection of dam profiles has ever before appeared in print, assembled together on a common basis.

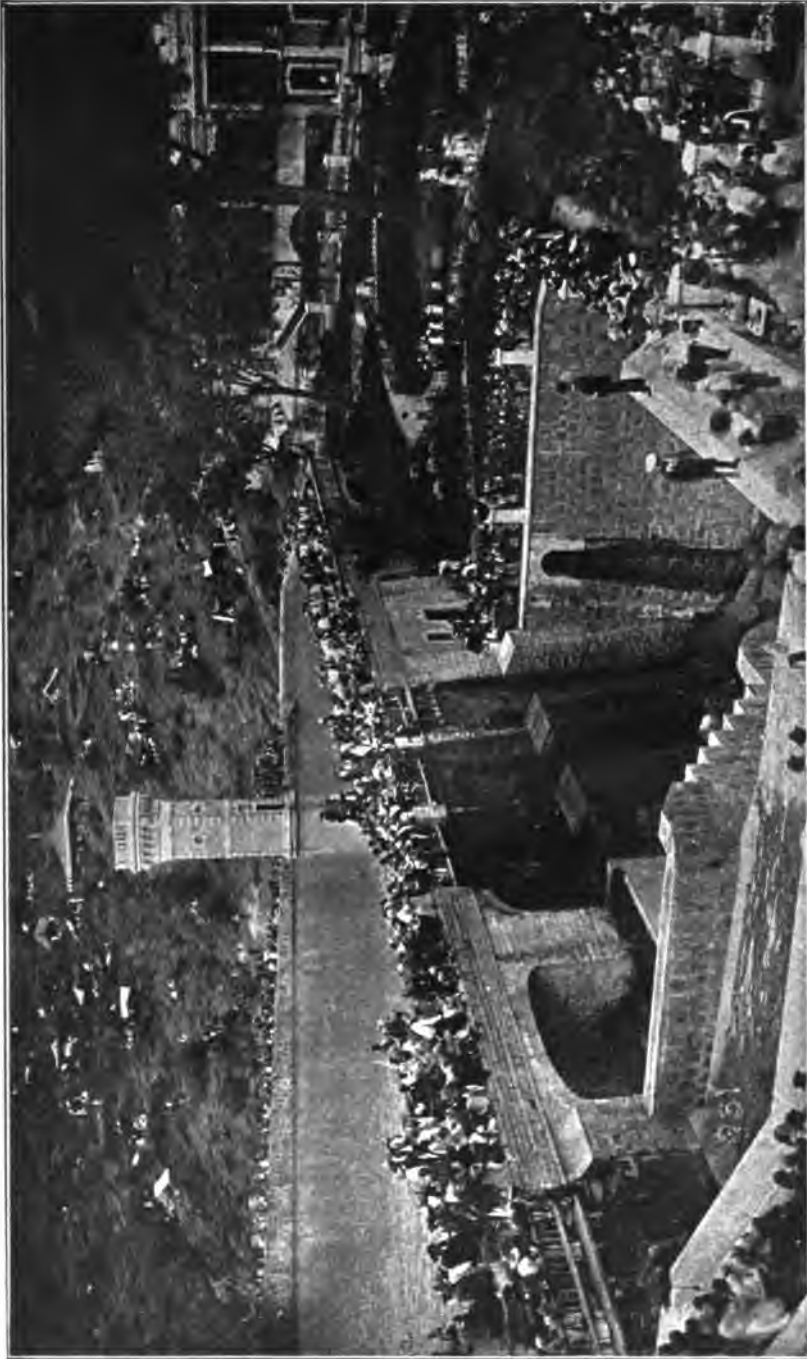
FIG. 255.—Lower Dam, or "PRESA DE LA OLLA," GUANAJUATO, MEXICO. VIEW TAKEN DURING THE FEAST DAY WHEN THE GATES ARE RAISED AND THE RESERVOIR EMPTIED.
[Frontispiece.]

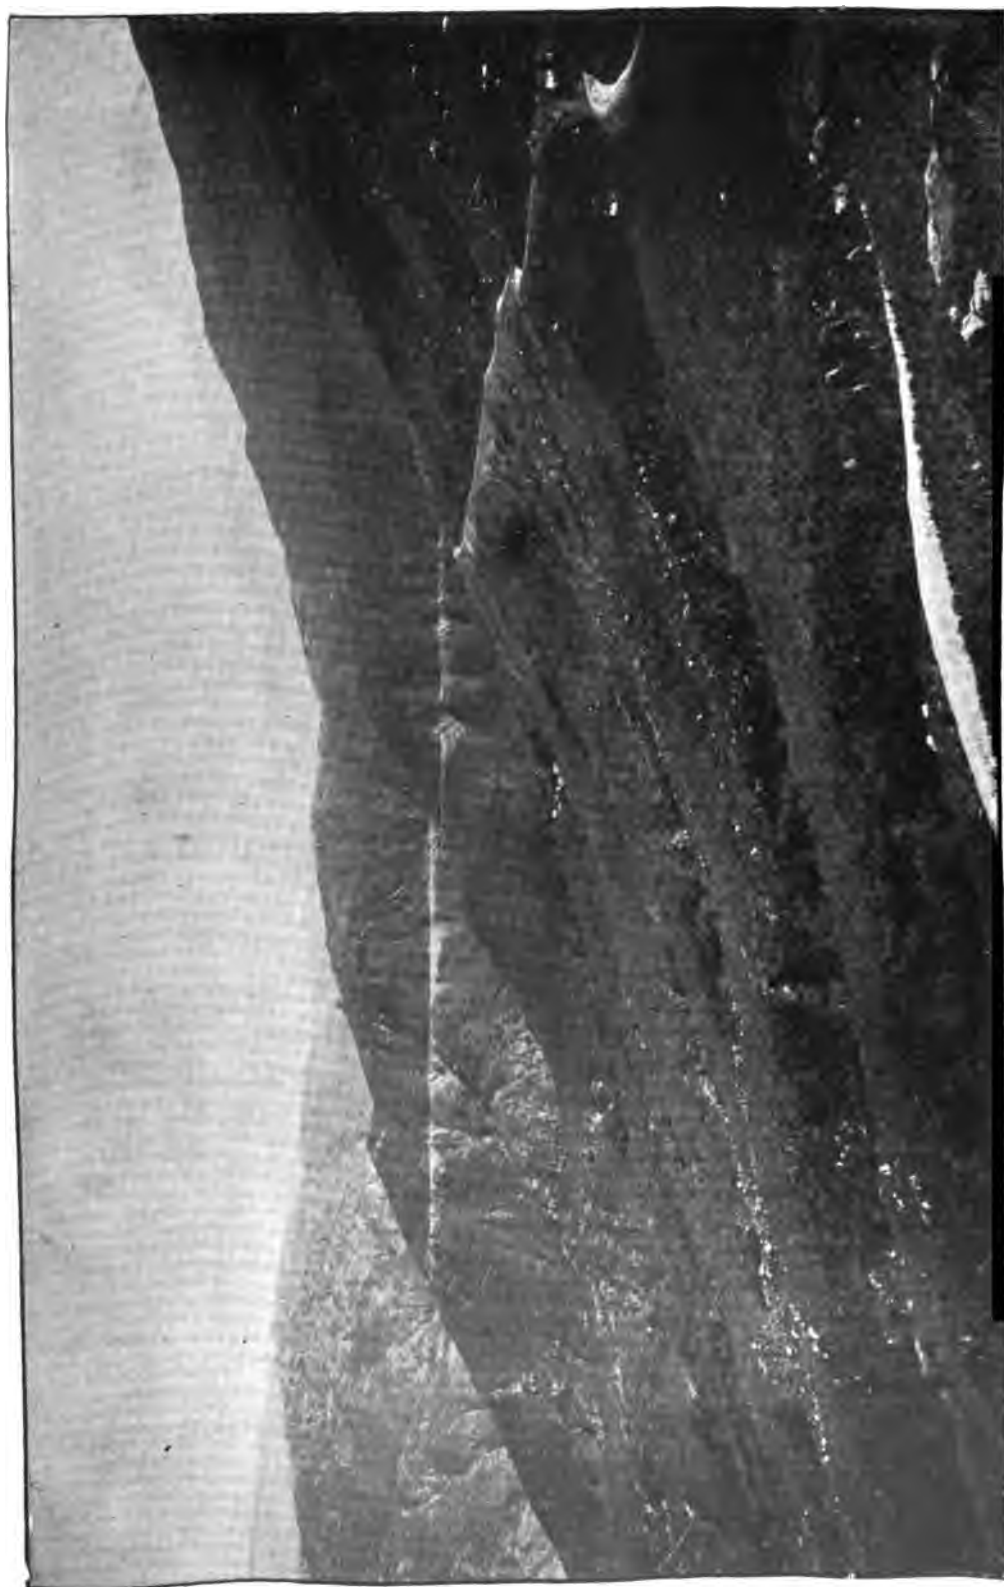
FIG. 2.—FEEDER CANAL ON THE SIDE OF RODRIGUEZ MOUNTAIN, ESCONDIDO IRRIGATION DISTRICT.

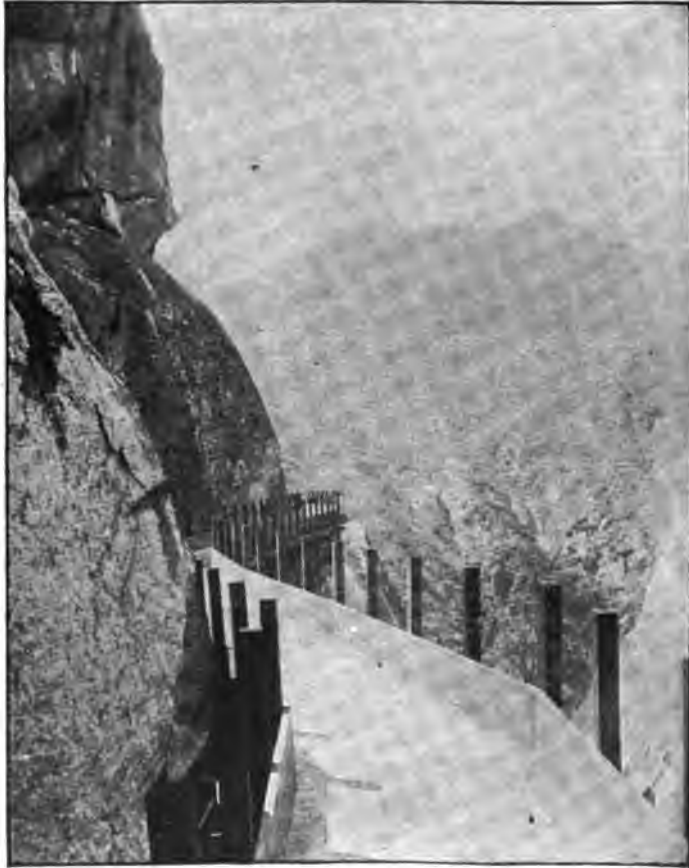
FIG. 3.—FEEDER CONDUIT OF ESCONDIDO IRRIGATION DISTRICT.

The upper 8000 feet of the conduit consists of a flume (Fig. 3), supported on posts on the sides of a rugged canyon, which in places presents a vertical face of considerable height. The lumber of this flume was hauled by a roundabout road to a bluff on the opposite side and 600 feet above the river-bed, whence it was transported by a wire cable with a span of 1500 feet by means of a trolley manipulated by hand windlass and rope. At other points the lumber was hoisted to the line by horse-power, by means of a car and portable track several hundred feet in height. The flumes are mainly 4 feet wide by 3 feet deep, and the ditch is excavated with a bottom width of 5 feet and side slopes of 1 on 1, the minimum excavation on the lower side being about 3 feet. The formation throughout that region is granitic, partially decomposed, the disintegration of the rock forming a few feet of soil, from which protrude large boulders of very hard granite embedded in softer rock *in situ*.

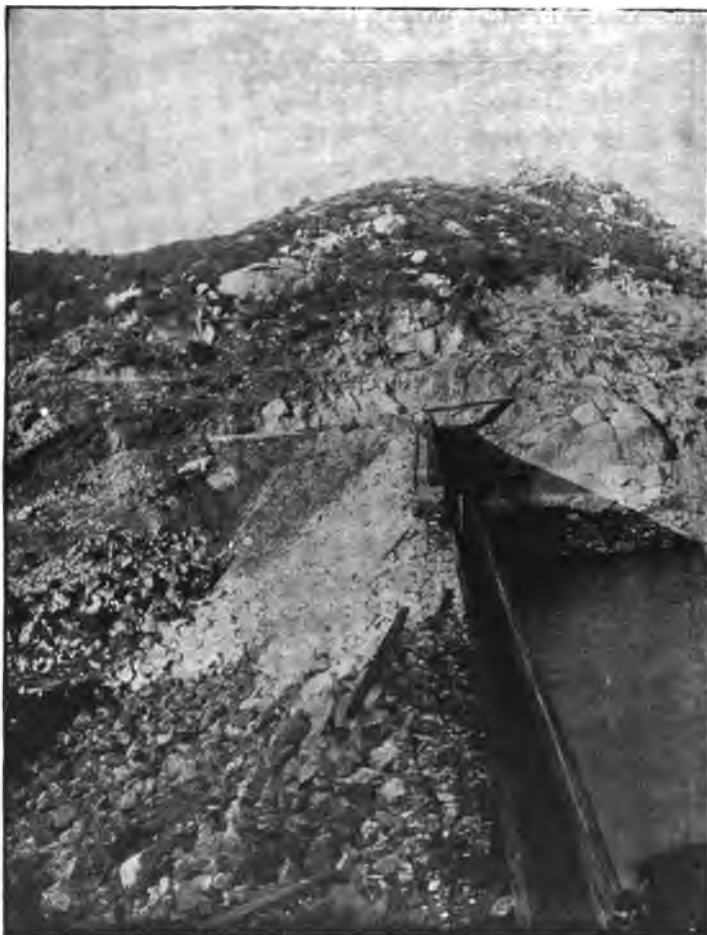
FIG. 4.—ESCONDIDO IRRIGATION DAM, LOOKING NORTH, SHOWING SPILLWAY.

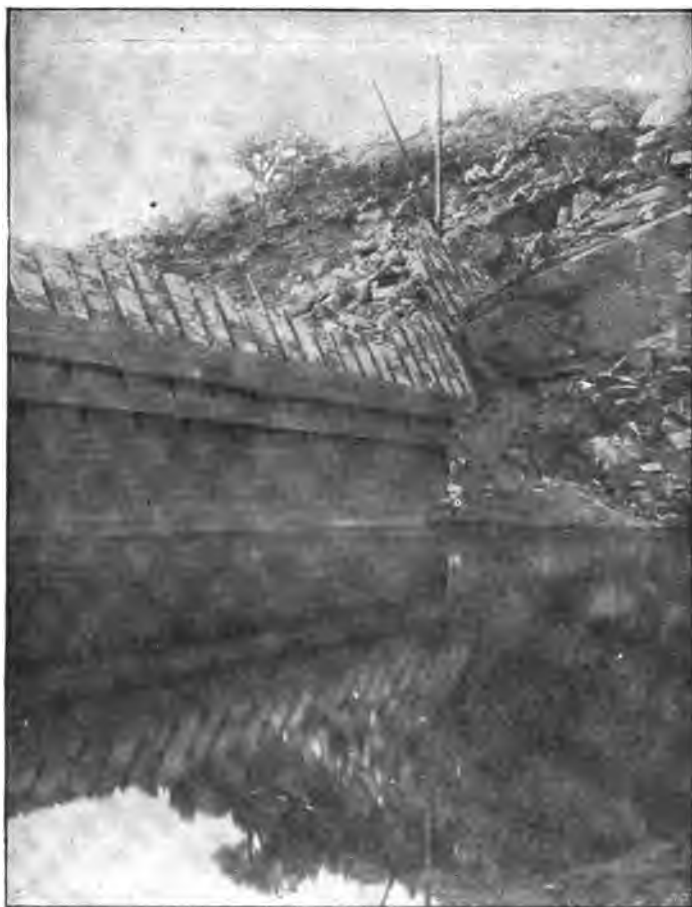
FIG 9.--CONSTRUCTION OF FACING OF ESCONDIDO DAM.

connected all around the toe with the canyon walls and bed. The dry wall forming the upper face of the dam was so laid as to embed in its surface a series of redwood timbers, 6" \times 6" in size, placed in vertical parallel lines, 5 feet 4 inches apart between centers. These timbers projected 2 inches beyond the face of the wall, and the planks were spiked to them. As each row of plank was put in position, beginning at the bottom, concrete was rammed into the 2-inch space between the plank and the face of the wall, giving a full bearing for the plank throughout. This provision was certainly a wise one, and so far as the writer is informed was never employed before in the dams of this class previously constructed. On the lower third of the dam the facing plank are 3 inches thick, on the middle third 2 inches, and on the upper third 1½ inches, all being doubled throughout. Joints were broken as far as possible, both at the vertical and the horizontal seams, by the second layer, and they were calked with oakum and smeared with hot asphaltum.

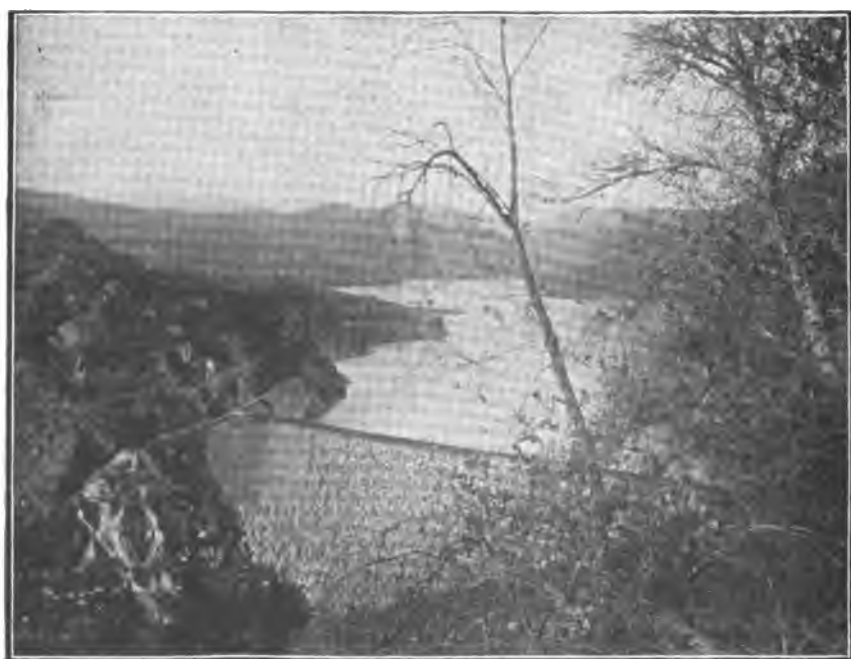
FIG. 10.--ESCONDIDO (CAL.) ROCK-FILL DAM. WOODEN LINING.

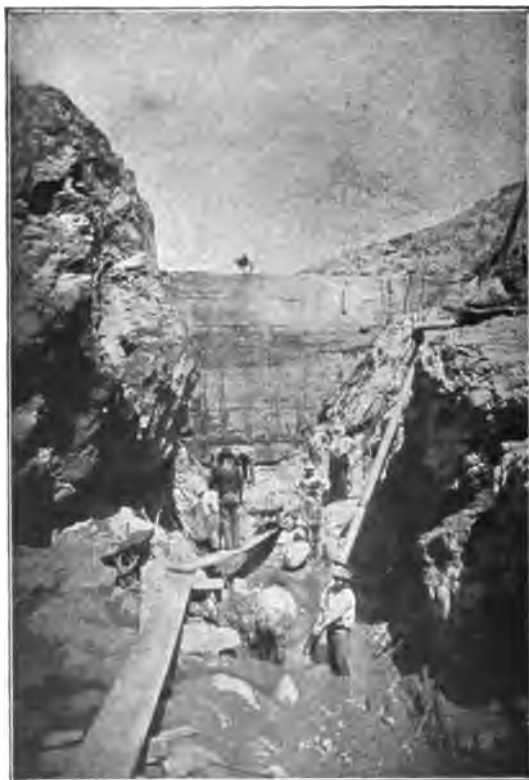
FIG. 11 — MASONRY FOUNDATION OF LOWER OTAY DAM.

The site of the Otay dam was an ideal one for a masonry structure, because of the satisfactory character of the bed-rock foundations, and the abundance of suitable rock and sand at the site, while its convenience to a port of entry rendered the cost of cement very moderate. The usual incentive for building rock-fill dams in preference to masonry, due to their remoteness and the high cost of freighting cement to the site was lacking in this case, and in fact the work was originally planned as a masonry dam. A foundation was laid for this purpose 65 feet thick at the base, reaching down to a depth of 31.4 feet below zero contour, and carried up to a height of 8.6 feet above zero, with a length on top of 85 feet. A view of the work is shown in Fig. 11.

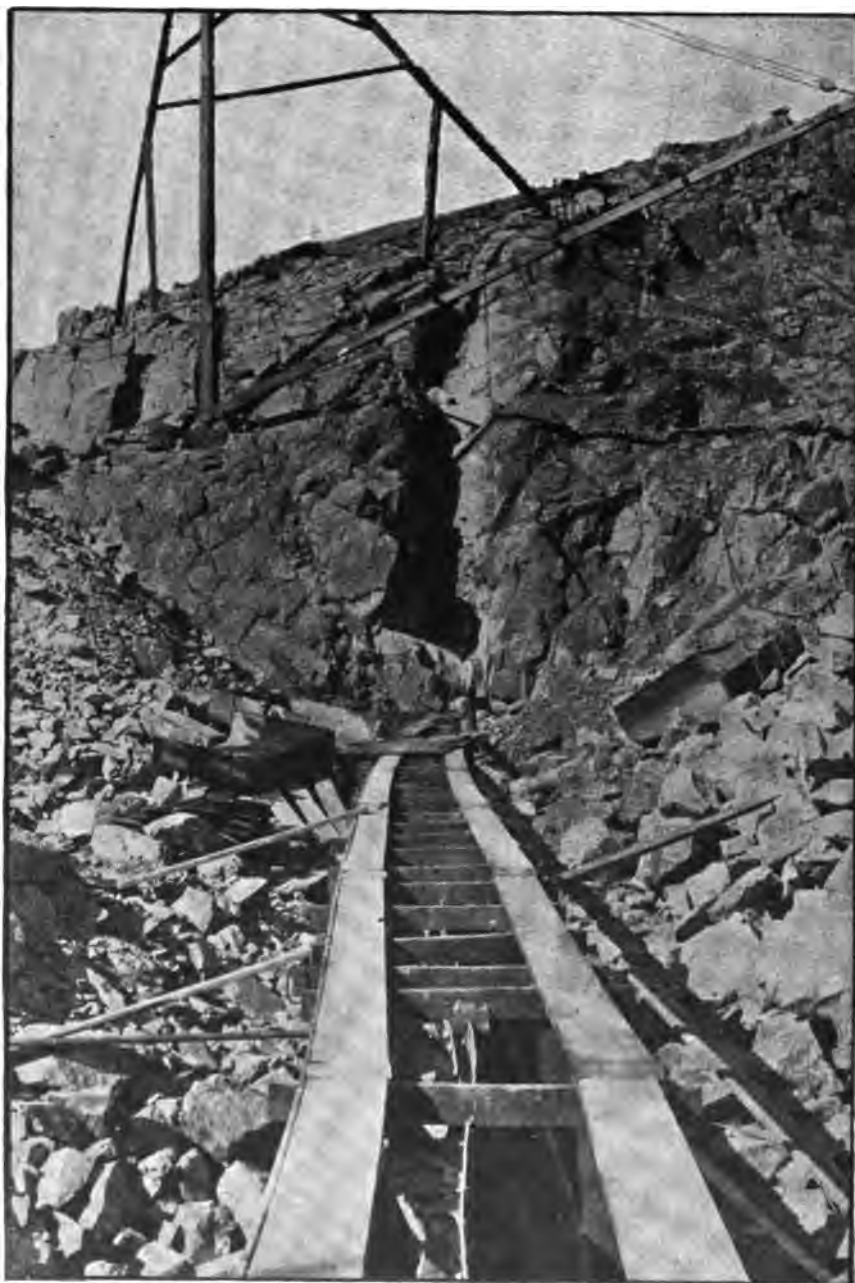
FIG. 14.—STEEL WEB-PLATE AND ANCHOR-TRENCH AT WEST END OF LOWER OTAY DAM.

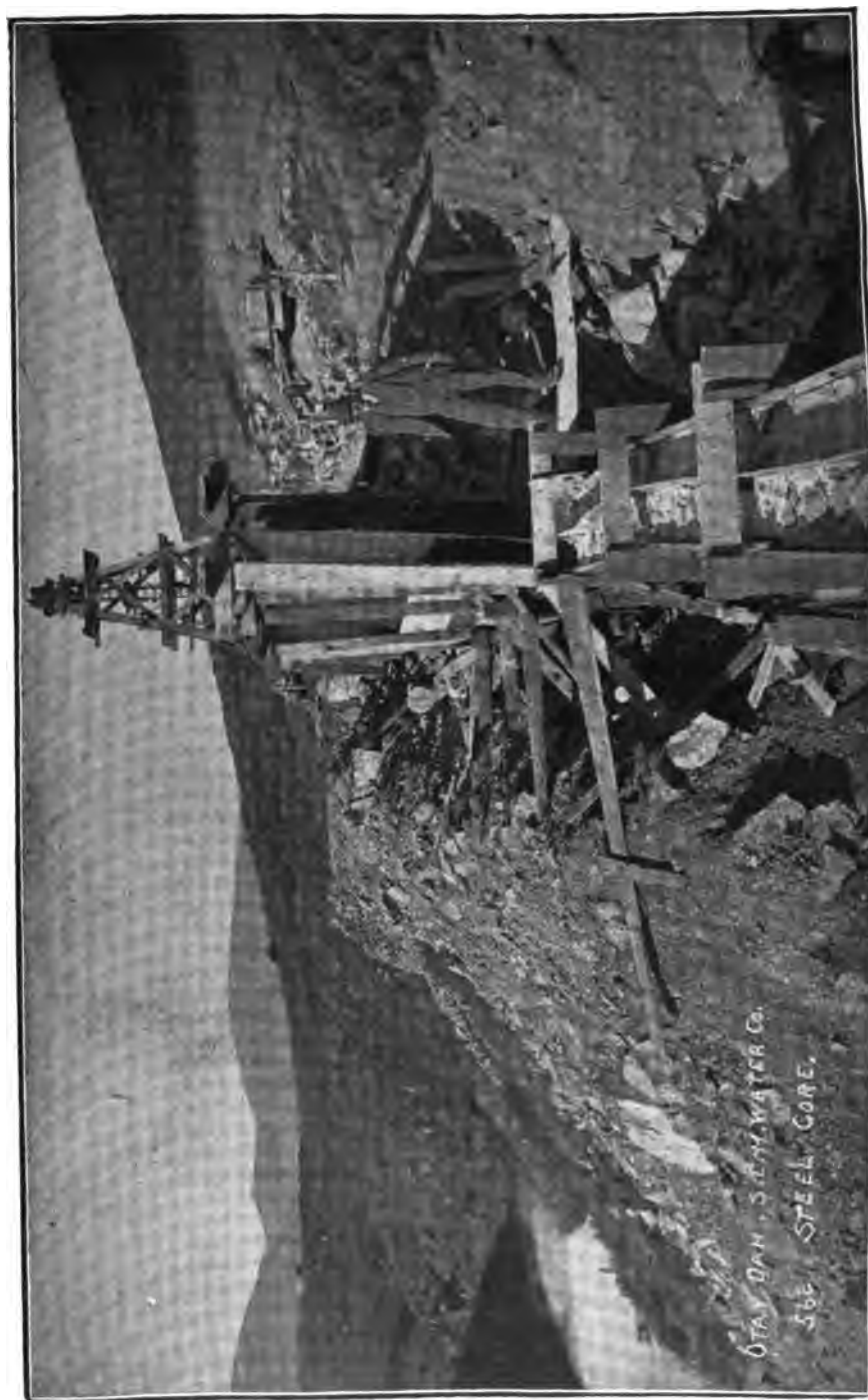
OTAY DAM, S. E. M. WATER CO.
SEE STEEL CORE.

FIG. 15.—OTAY (CAL.) ROCK-FILL DAM -STEEL CORE.

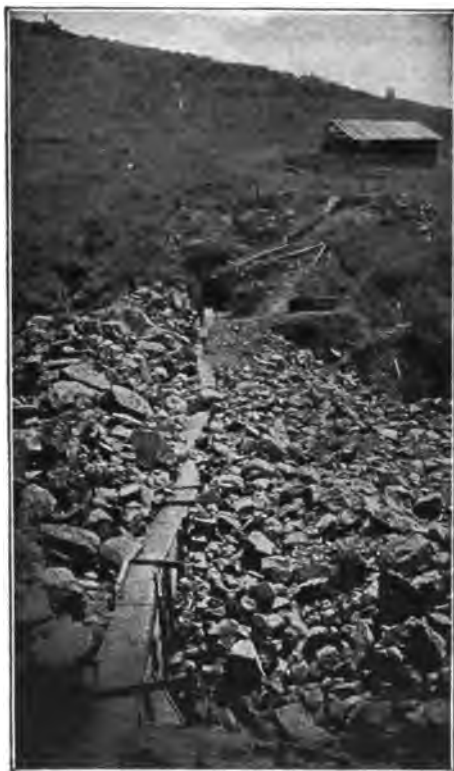
FIG. 16.—CREST OF LOWER OTAY DAM, SHOWING WEB-PLATE OF STEEL EMBEDDED IN CONCRETE. DAM NEARING COMPLETION.

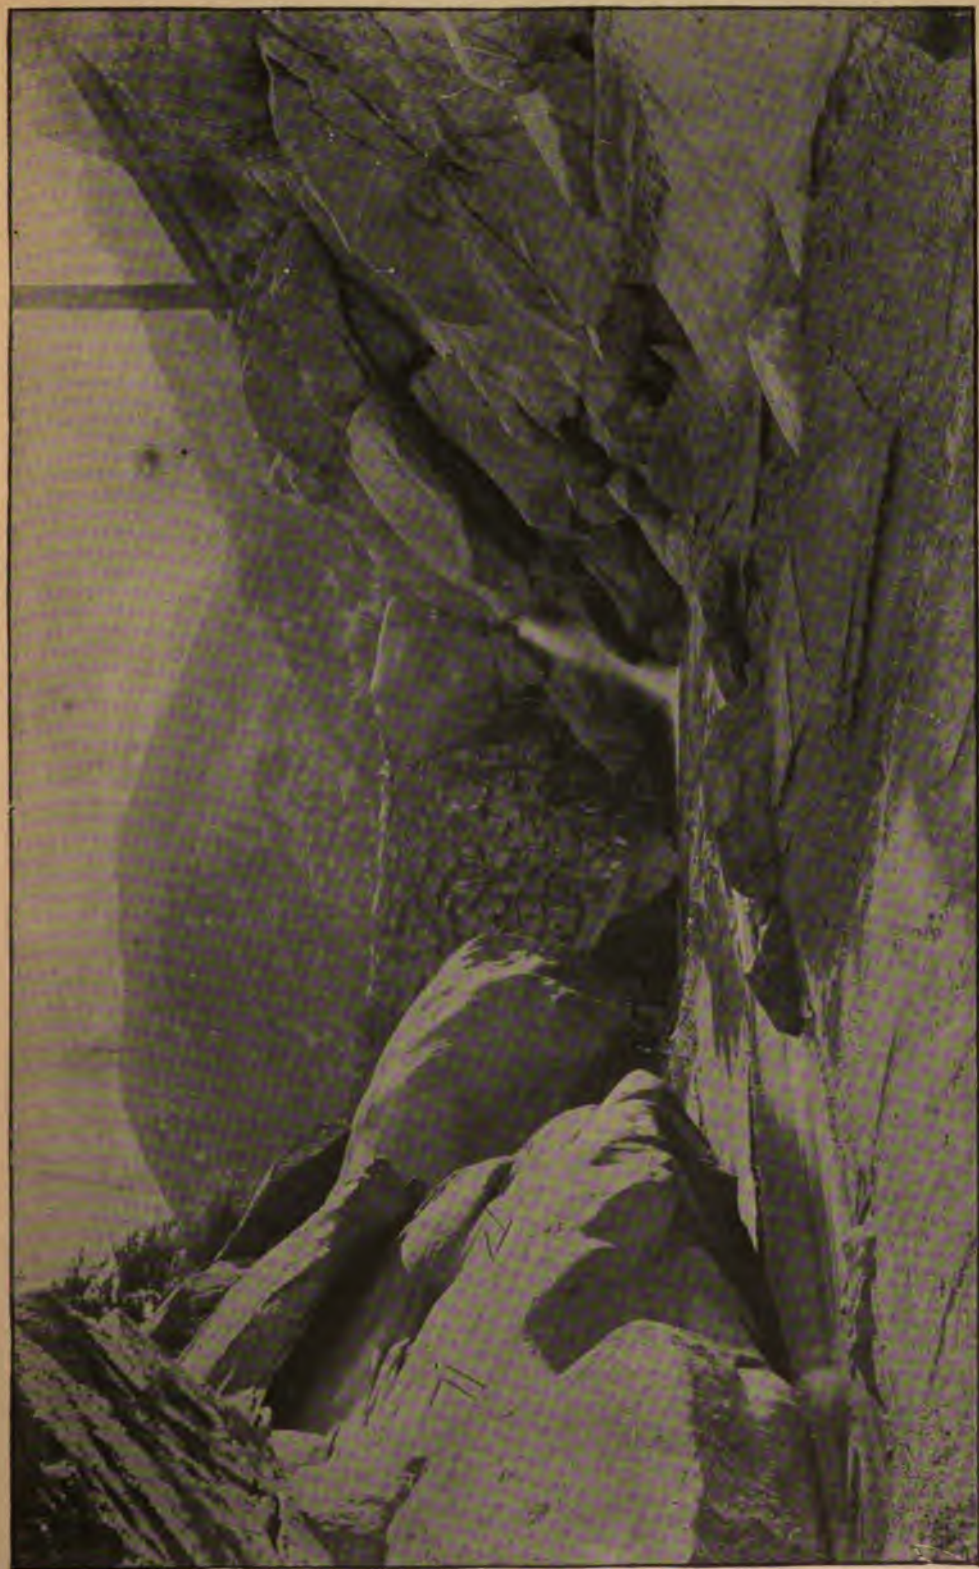
FIG. 20.—THE BARRETT DAM-SITE, SHOWING THE BEGINNING OF MASONRY FOUNDATIONS.
The material on left bank above the rock here shown is disintegrated granite to such depth as to require change of plans from original design.

In 1897 the company erected a masonry dam, shown in Fig. 20, 72 feet in height from its base, which is 22 feet below the stream-bed, to its top 50 feet above. This structure rests on solid granite bed-rock throughout, and is 14 feet thick at bottom, 5 feet at top, and about 30 feet long on the crest. This was to be used simply as a pick-up weir to divert water into the Dulzura pass conduit. Subsequently it was decided to build a storage dam, similar in plan to that of the Lower Otay, to an extreme height of 175 feet, and a new location was chosen about 1000 feet further down stream, where rock could be more conveniently obtained for a rock-fill structure. Here a new masonry dam was built in 1898, reaching to bed-rock in the stream-bed and extending about 35 feet above, upon which to begin the sheet-steel core of the rock-fill. The dimensions were as follows:

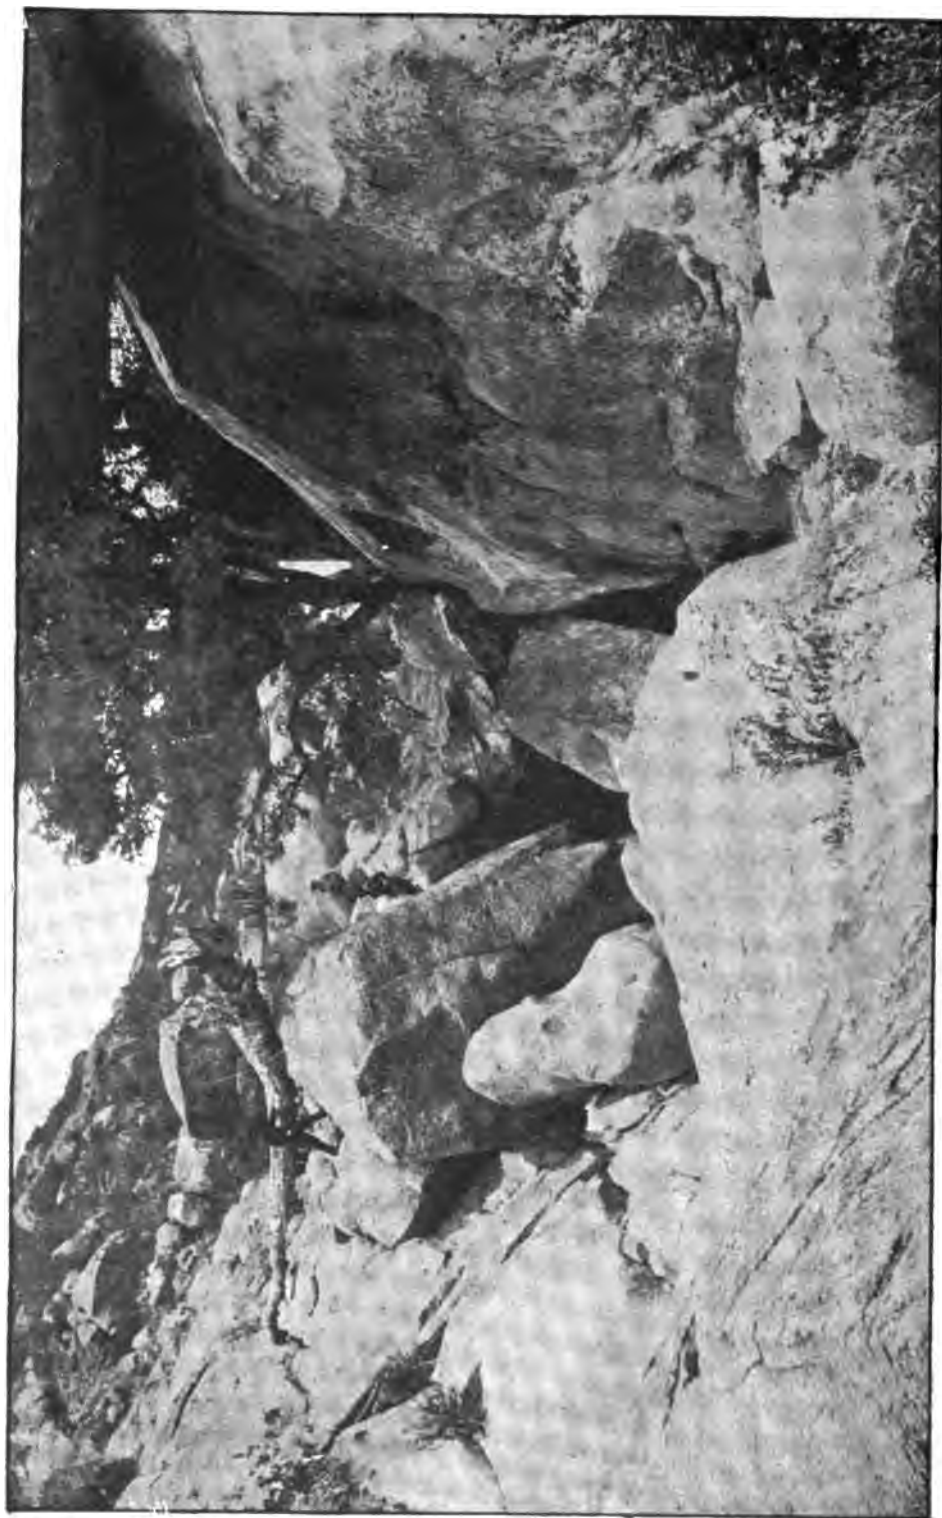
FIG. 21.—MORENA DAM-SITE, LOOKING EAST.

100 feet deep below the stream-bed. Fig. 21 is a view taken of the dam-site looking up stream, and well illustrates the character of the rock-masses filling the gorge. The tree growing at the right of the picture is on the line of the masonry toe-wall. This wall was carried down to the bottom of the fissure, 112.5 feet below the general stream-bed at that point. This wall is at the upper toe of the rock-fill, and is 36 feet thick at the bottom, where the width between solid walls was but 4 feet for a height of 12 feet. The widest part of the fissure was 16 feet, and at the zero contour it was 80 feet wide. At this point the thickness of the masonry was made 20 feet. It was carried up 30 feet higher, where the thickness is 12 feet. The top of the wall is shown in the view of the partially finished dam (Fig. 22) just above the water-line. The upper toe of the rock-fill, which will be finished on a slope of $1\frac{1}{2}$ to 1, will reach to the top of this toe-wall, and will be covered with 5 feet of Portland cement, uncoursed rubble masonry, over which it was intended to lay a sheet of asphalt concrete, 12 inches thick at base and 4 inches thick on top, extending into a groove moulded in the wall, 5 feet in depth. The plan for using asphalt concrete has been abandoned recently and some other material will be substituted. The rock-fill, as shown by this view, is about 80 feet high above the wall.

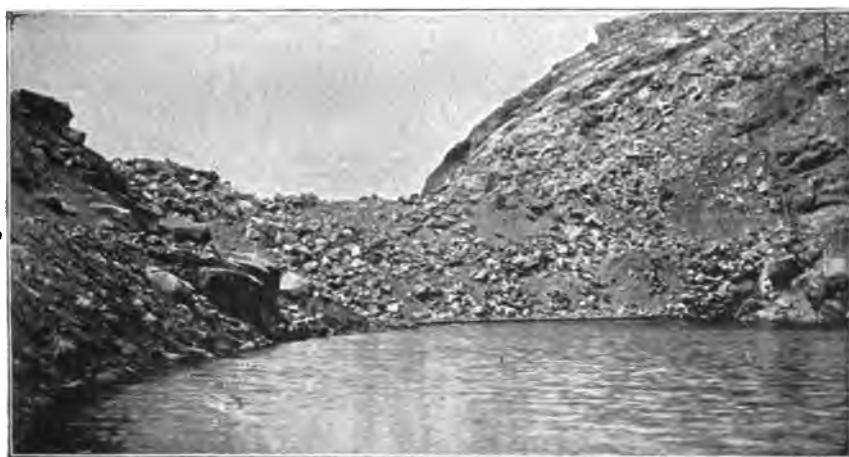
FIG. 22.—MORENA ROCK-FILL DAM IN PROCESS OF CONSTRUCTION. SHOWING TOP OF TOE-WALL ABOVE THE WATER-LINE.

The machinery assembled for the construction is said to have cost \$175,000. Two lines of Lidgerwood cableway span the chasm at a height of 400 feet, operating from the quarries on either side. These cableways are attached to heavily ballasted cars, supported on three lines of railway-track on either side, with a range of movement of 100 feet each, parallel with the axis of the dam. Powerful derricks of the most improved types

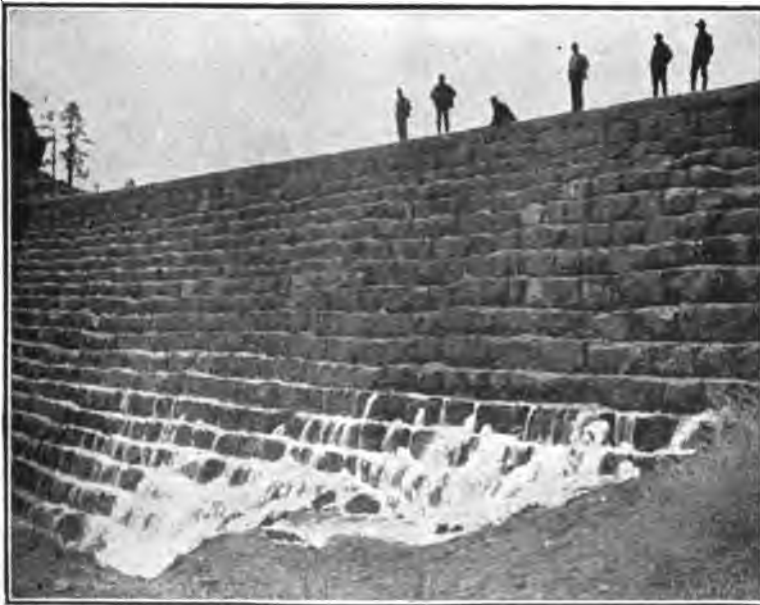
FIG. 30.—CASTLEWOOD DAM, COLO., SHOWING LEAKAGE THROUGH ROCK-FILL.

spillway at the side, while the discharge pipes were wide open. At the same time a large volume of water found its way through the cracks in the masonry wall, and poured out in large streams through the rock-fill for 10 to 15 feet above the base.

The photograph, Fig. 30, shows an enormous amount of this leakage, and the cause for the alarm created in Denver, which lies directly in the path of the escaping water. That the dam was able to withstand such a volume of leakage is a testimonial to the stability of rock-fill dams, which in this case afforded such complete drainage as to be unaffected by leakage that would immediately have destroyed an all-earth dam.

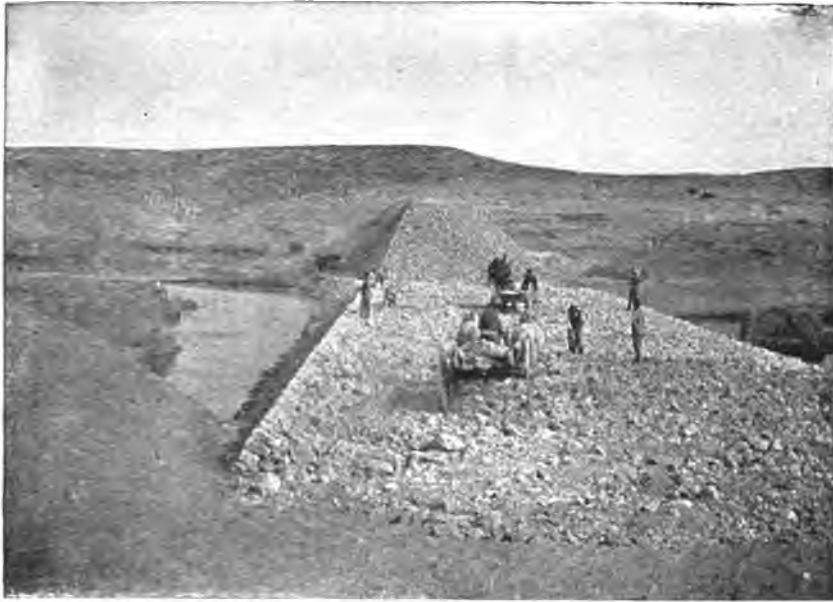
FIG. 33.—LAKE AVALON DAM. ROCK-FILL IN PROCESS OF CONSTRUCTION.

fill before the addition of the earth facing is illustrated by Fig. 33, a view taken during construction. Fig. 34 is a view of the finished dam, taken in 1892. The grade of the main canal leading out from the dam on the east side of the valley is 10 feet above the base of the dam, and is excavated in limestone to a maximum depth of 38 feet. Fig. 35 is a view of the main canal and headgates, taken from the lower side.

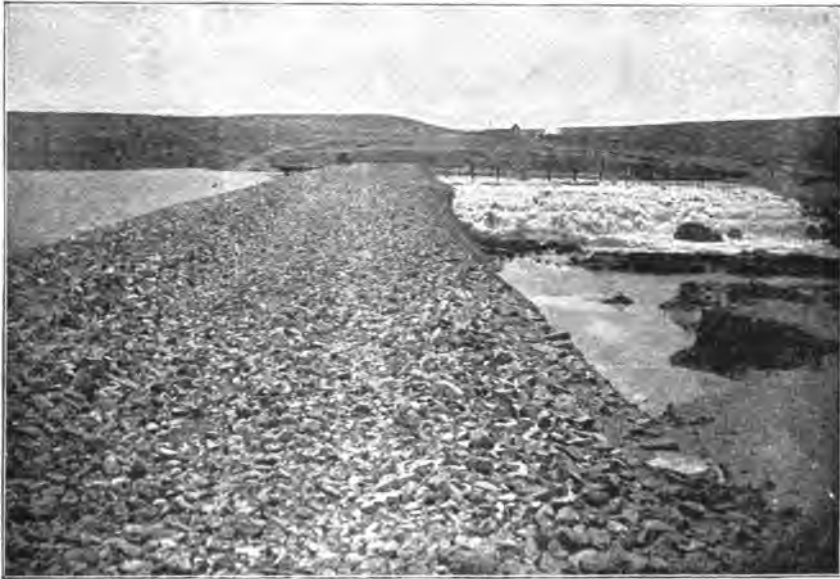
FIG. 34.—LAKE AVALON DAM, PECOS RIVER, NEW MEXICO SHOWING THE CREST OF COMPLETED DAM AND SPILLWAY DISCHARGING.

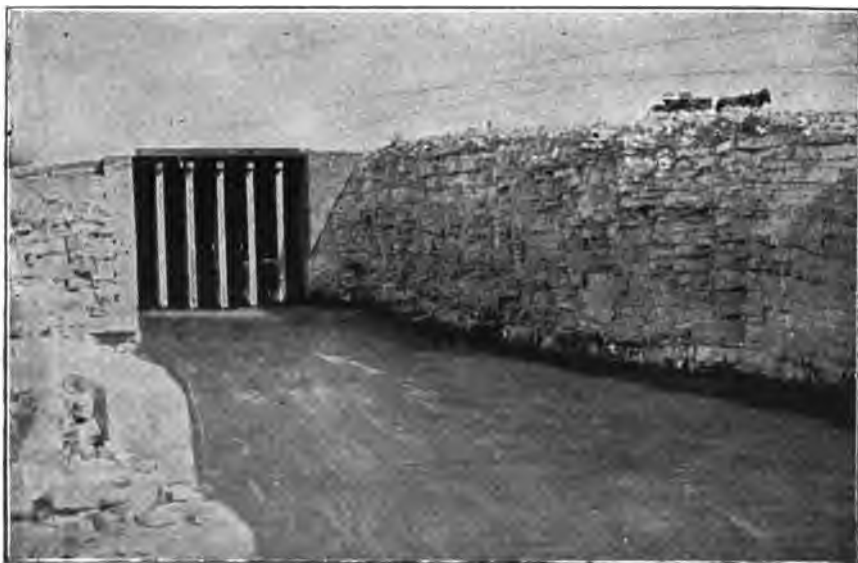
FIG. 35.—CANAL HEADGATES, LAKE AVALON DAM.

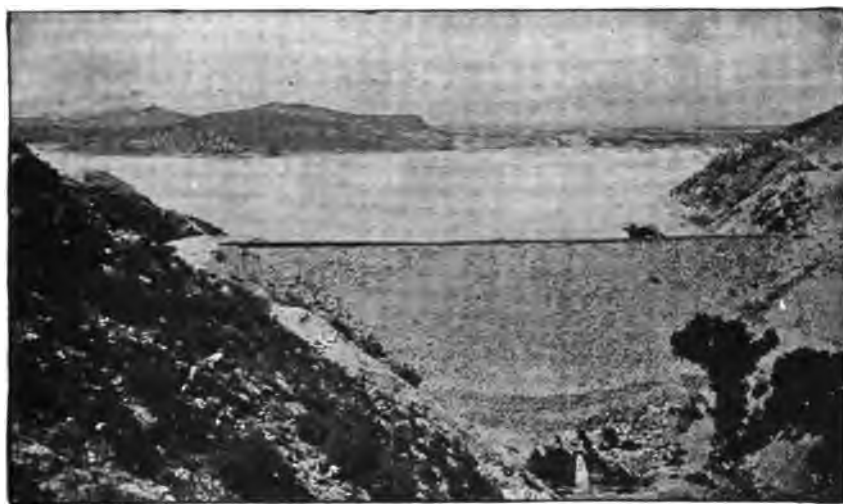
FIG. 41.—VIEW OF WALNUT GROVE DAM, ARIZONA.

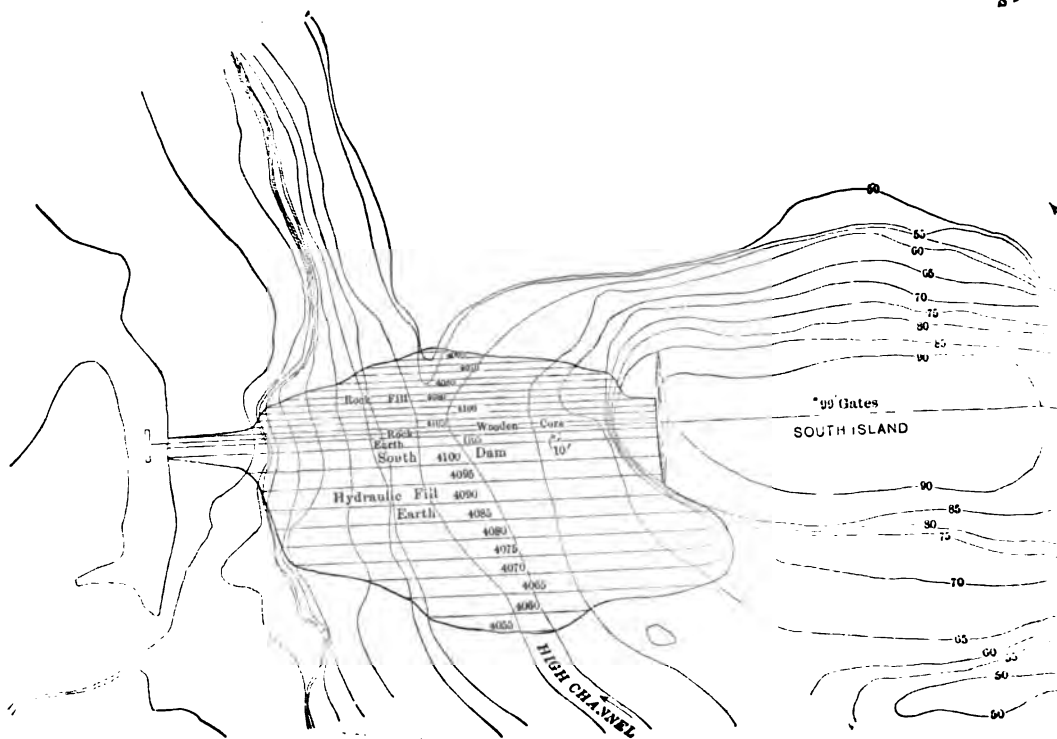
**PLAN OF
THREE COMBINATION HYDRAULIC-FILL AND ROCK-FILL DAMS,
MILNER, IDAHO
AT HEAD OF TWIN FALLS CANAL ON SNAKE RIVER.**

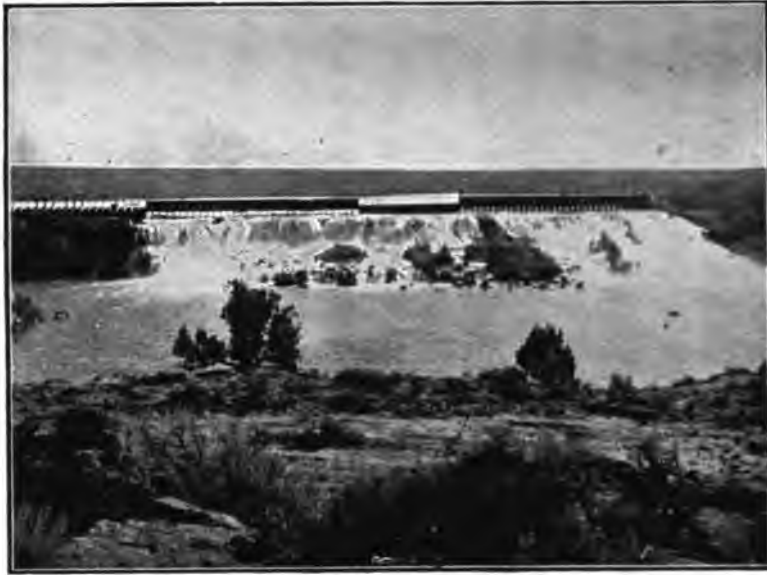
FIG. 47.—MILNER DAM, SNAKE RIVER, IDAHO. DISCHARGE THROUGH THE GREAT BATTERY OF 99 WASTE-GATES FORMING "IRRIGATION FALLS," 40 FEET HIGH.

Figs. 47, 48, 49, 50, 51, and 52 illustrate the construction of these notable dams, and Fig. 53 shows the type of head-gates successfully

The Milner Dam, Idaho.—The photograph shown in Fig. 355 gives a more comprehensive picture of the three combination dams described on page 60 than any of the other illustrations accompanying the article (see Figs. 47 to 53), and will therefore add to the interest in these important and successful dams.

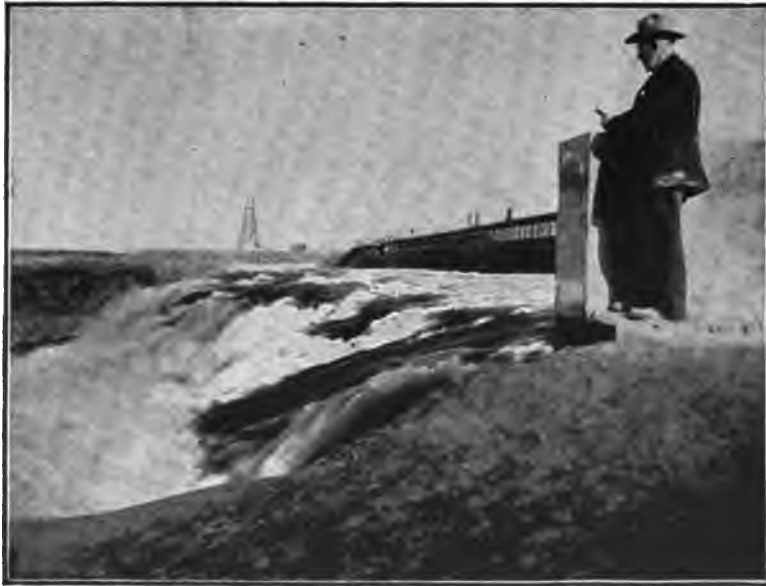
FIG. 48.—MILNER DAM, SNAKE RIVER, IDAHO. SHOWING WASTE-WAY GATES AND DISCHARGE OF RIVER OVER "IRRIGATION FALLS."

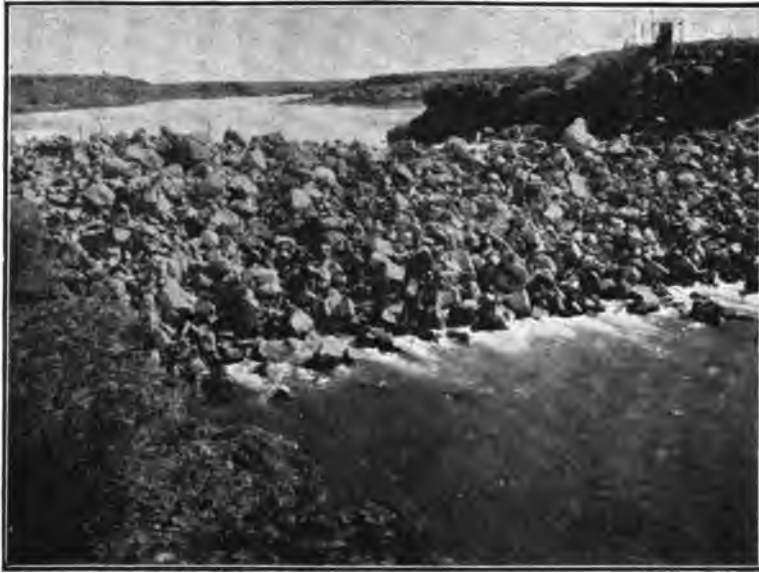
FIG. 49.—MILNER DAM, SNAKE RIVER, IDAHO. NORTH CHANNEL DAM BEFORE COMPLETION OF SHEET PILING. ABOUT 500 SECOND-FeET IS PASSING THROUGH ROCK-FILL, UNDER HEAD OF 13 FEET.

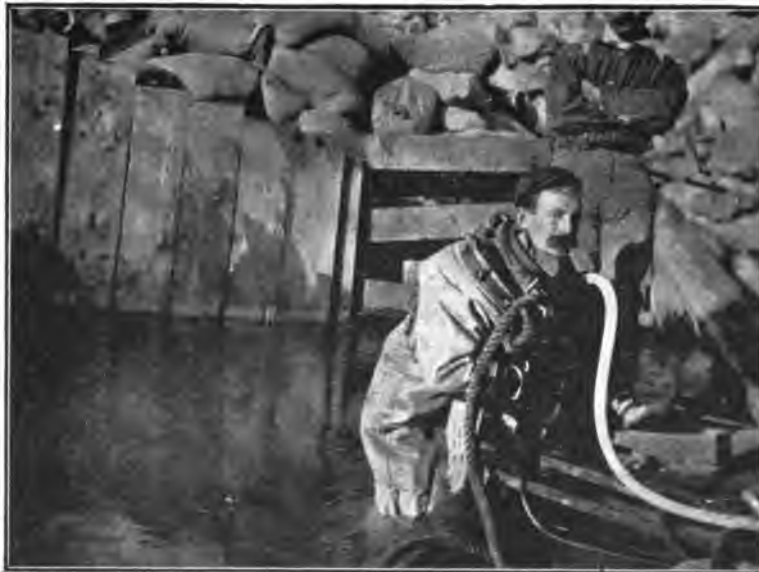
FIG. 50.—MILNER DAM. DIVERS AT WORK PLACING SHEET PILING IN 40 FEET OF WATER.

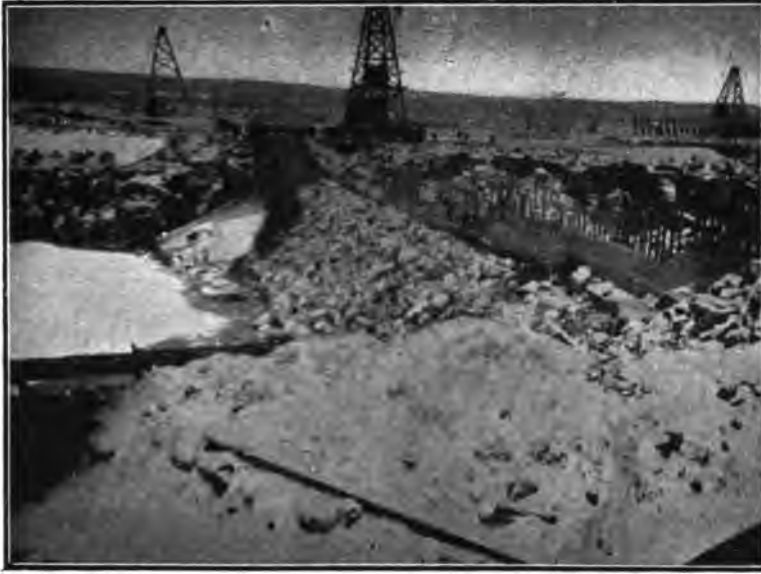
FIG. 51.—MILNER DAM, SNAKE RIVER, IDAHO. SHOWING ROCK-FILL WITH WOOD-CORE IN MAIN CHANNEL OF RIVER.

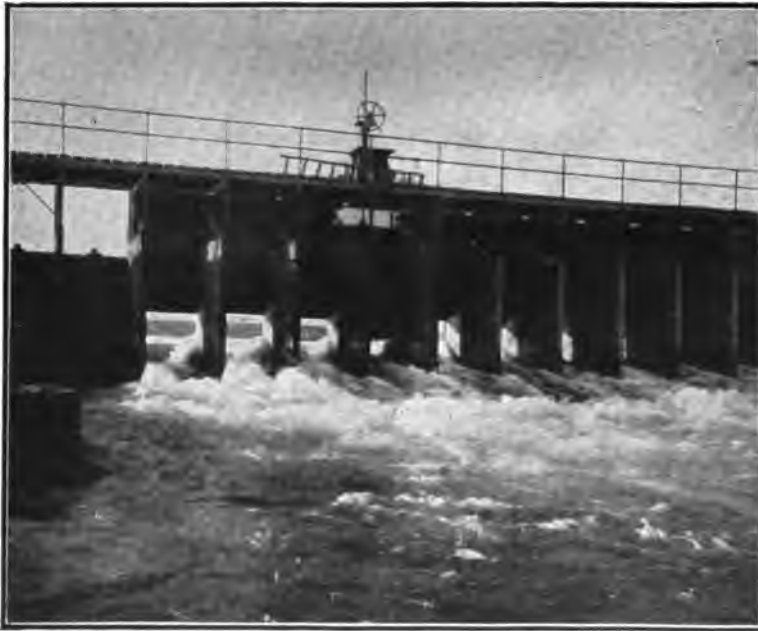
FIG. 52.—MILNER DAM, IDAHO. SHOWING A PART OF THE BATTERY OF 99 WASTE-GATES.

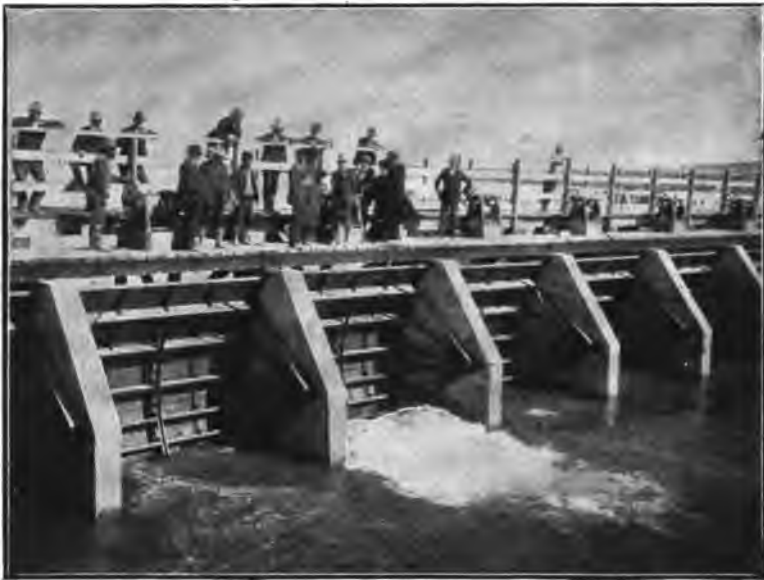
FIG. 53.—FIRST OPENING OF HEAD-GATES OF TWIN FALLS CANAL, MARCH 1, 1905.

used in the canal. They are eight in number, each 12 feet wide and 11 feet high. For description of hydraulic filling of these dams see pages 125 and 126.

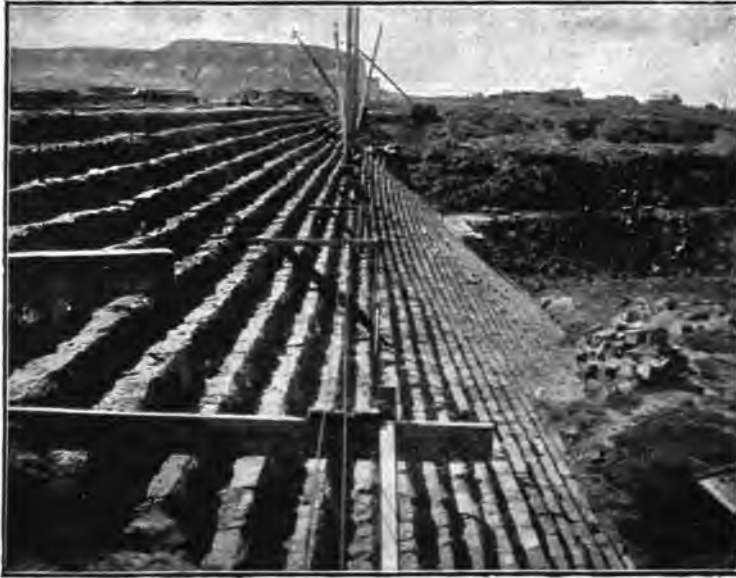
FIG. 55.—DOWN-STREAM FACE OF ZUÑI DAM. SHOWING CHARACTER OF DRY MASONRY IN THE ROCK-FILL.

Fig. 58 is a section of the dam, and Figs. 55, 56, 57, 59, 60, and 61 are photographs taken during construction.

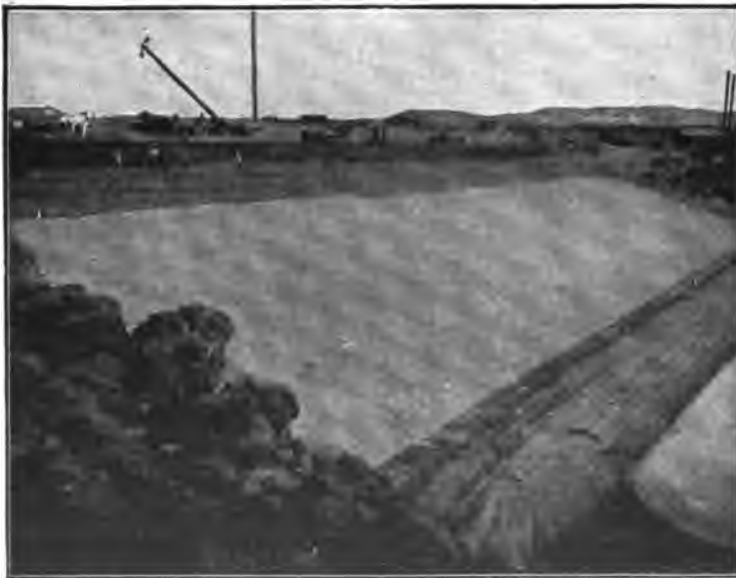
FIG. 56.—HYDRAULIC-FILL SIDE OF ZUÑI DAM. SHOWING GRAVEL COVER OF STONE RIPRAP.

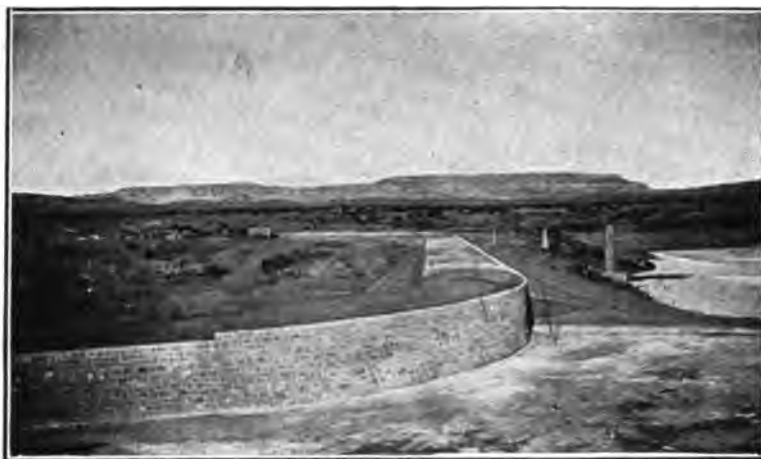
FIG. 57.—ZUÑI DAM, N. M., LOOKING NORTH, SHOWING TOWER AND BRIDGE IN DISTANCE, SPILLWAY GUARD-WALL IN FOREGROUND.

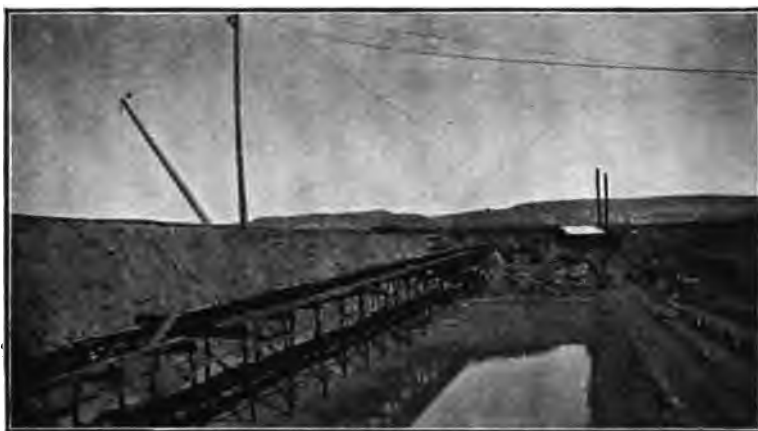
FIG. 59.—ZUÑI DAM, N. M., ILLUSTRATING METHOD OF DELIVERY OF SLUICED MATERIALS BY "V" FLUME, AGAINST FACE OF ROCK-FILL.

of sluicing was 12 cents per cubic yard, of which one-third was for pumping. The material was delivered along the dam by a "V" flume, measuring 20 inches on the sides, laid on a grade of 3%, and consisting of a

succession of sections, each 16 feet long, overlapping at the ends, and made to deliver material at any point by lifting out a section and inserting a lateral flume, directing the stream to either side as desired. Nearly one-half the entire amount of earth sluiced was deposited in the month of May, 1907, when the average delivery was 750 cubic yards per day

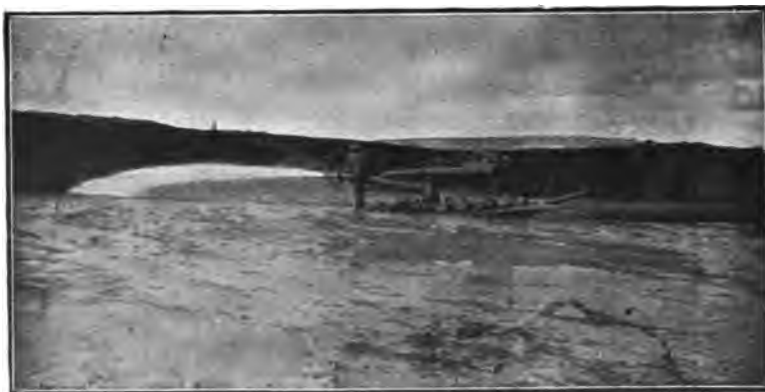
FIG. 60.—ZUÑI DAM, NEW MEXICO, SHOWING HYDRAULIC MONITOR IN ACTION.
